There are many reasons for rotary joint leakage. This chapter only deals with leakage caused by uncleaned internal fluids. In this case, the rotary joint can be inspected and the cause determined by examining the seal rings.

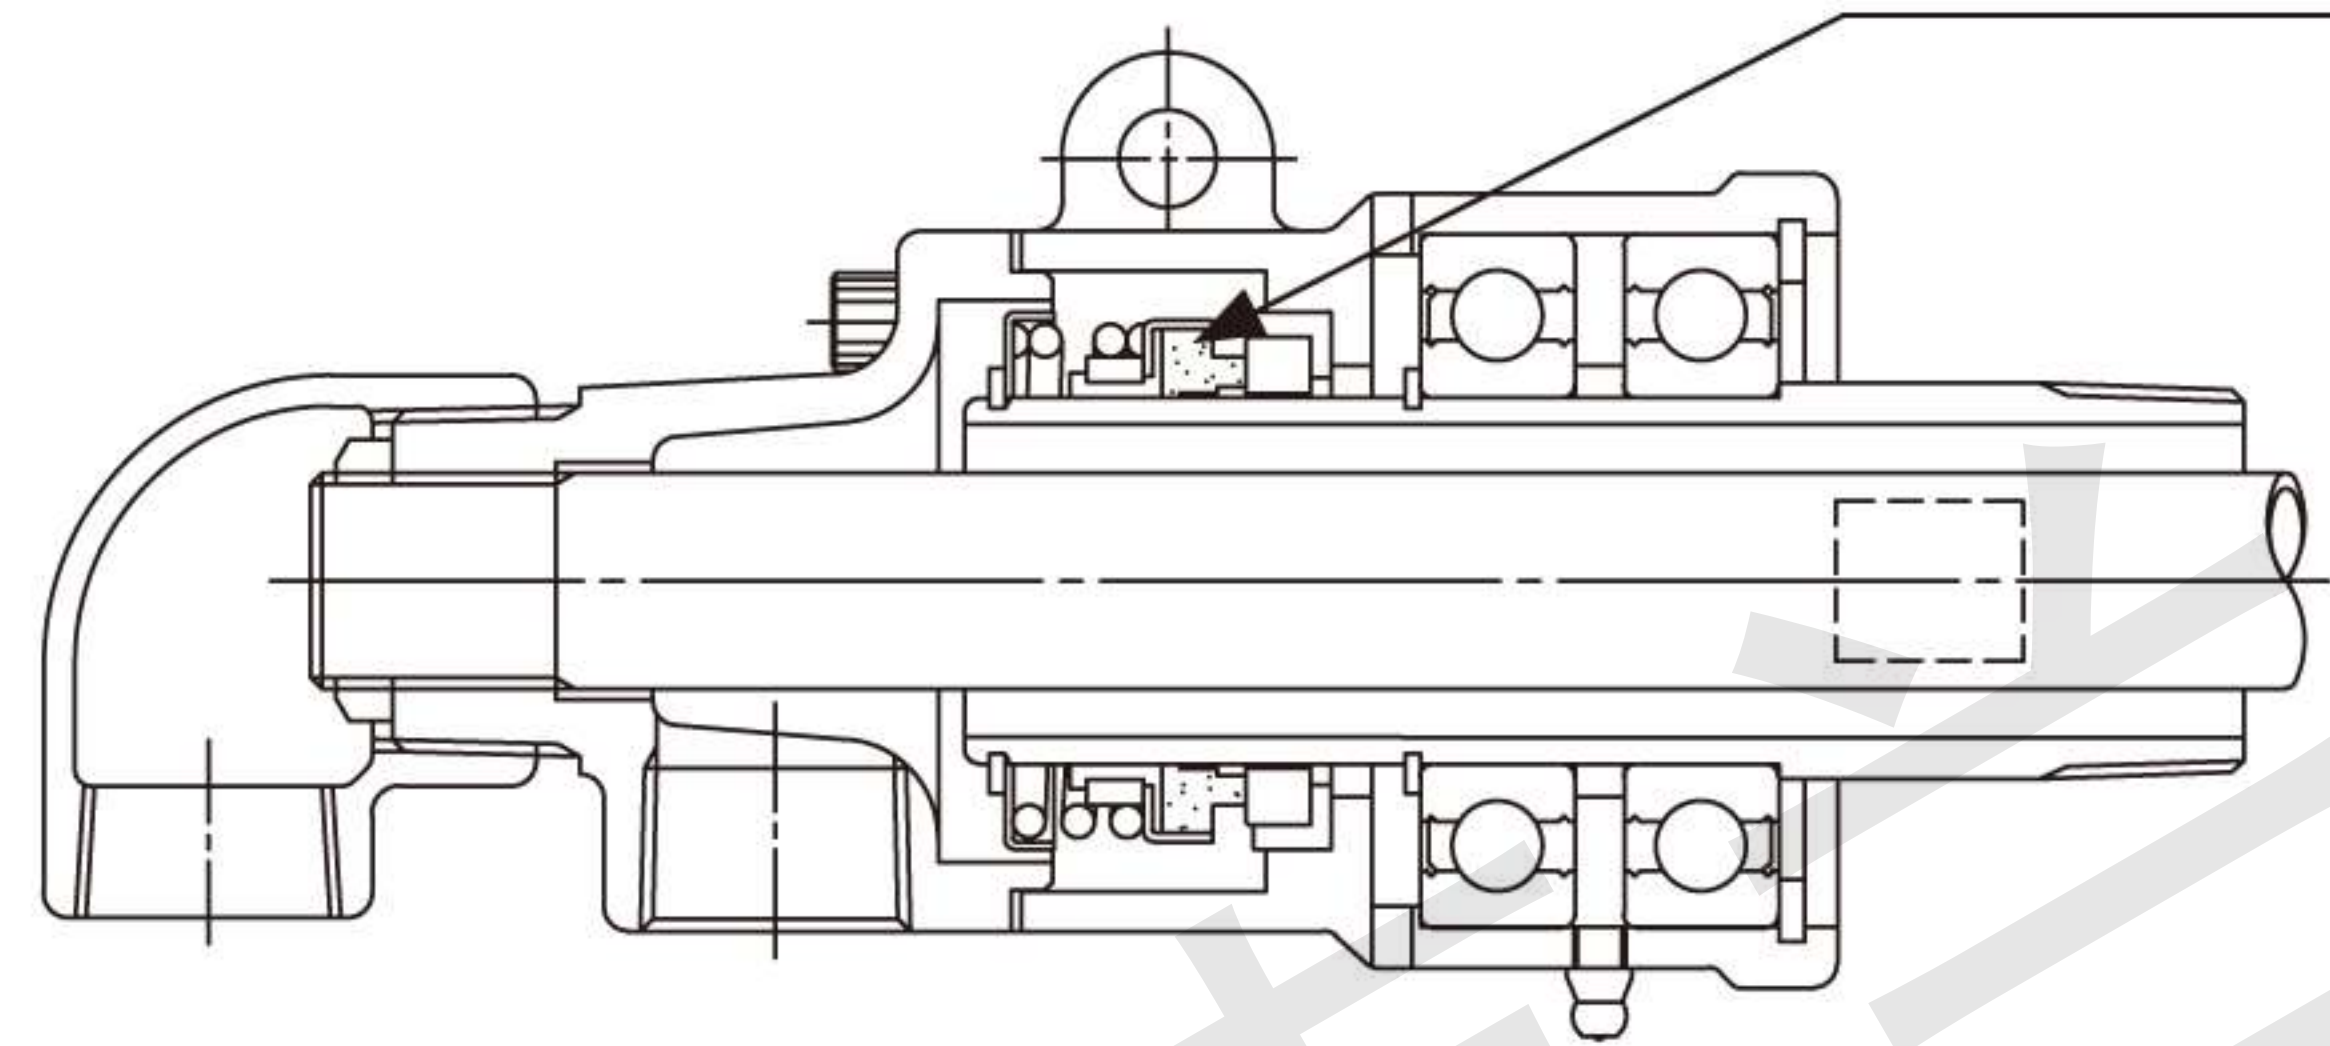
Fig.2

NOMAL CONDITION

If there are no impurities in the seal face, it will be smooth and bright. Any leakage would therefore most likely not have been caused by unclean fluids.

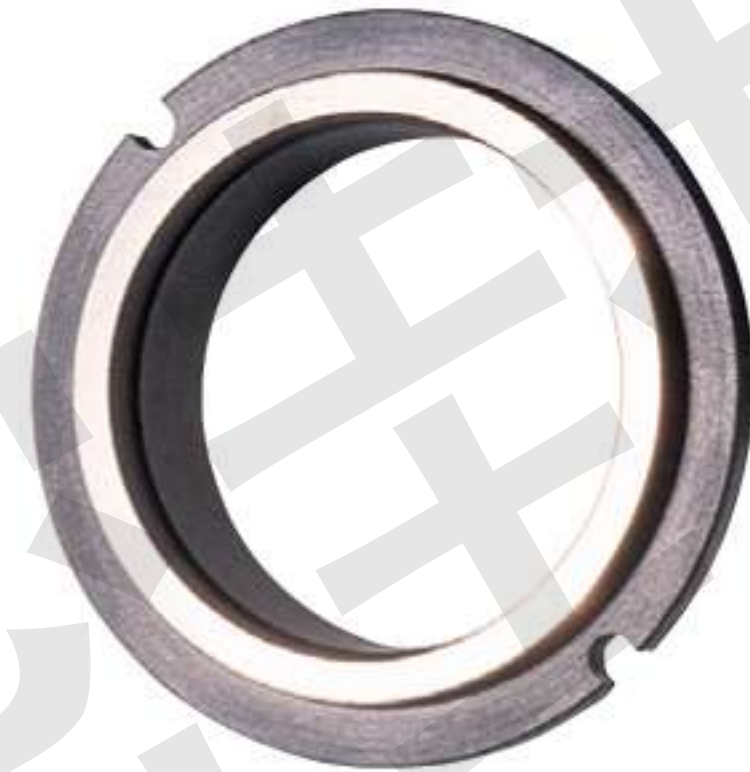
Fig.3

ABNORMAL CONDITION

If impurities get in the seal face, they will cause it to become rough and dull. In this case, unclean fluids would be mainly responsible for any leakage.

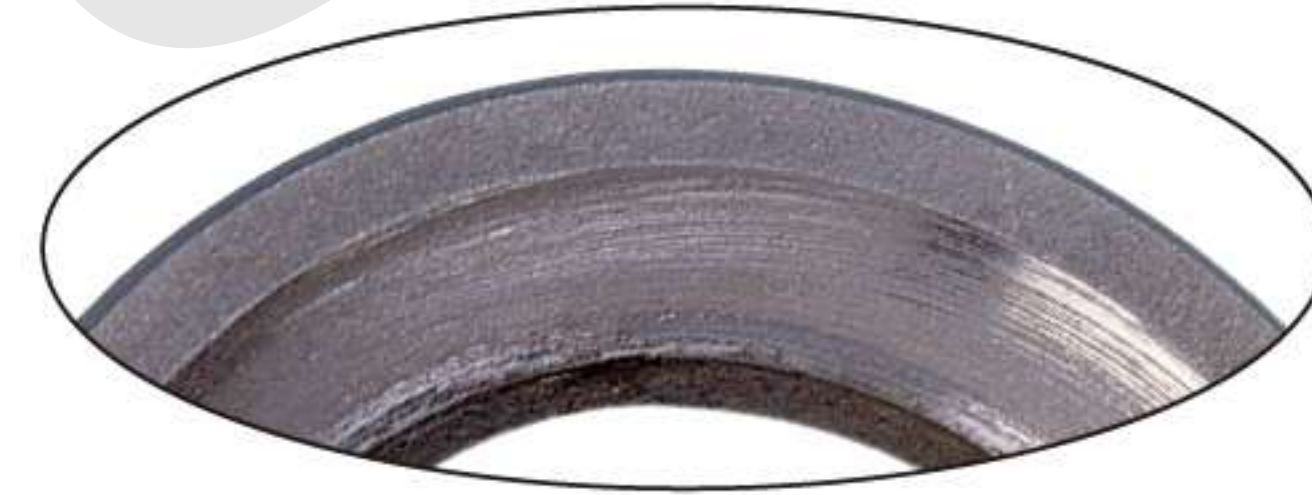
Fig.7

SERIOUS ABNORMAL WEAR

The severe wear shown was caused by coarse impurities. This will result in a lot of fluid being lost.

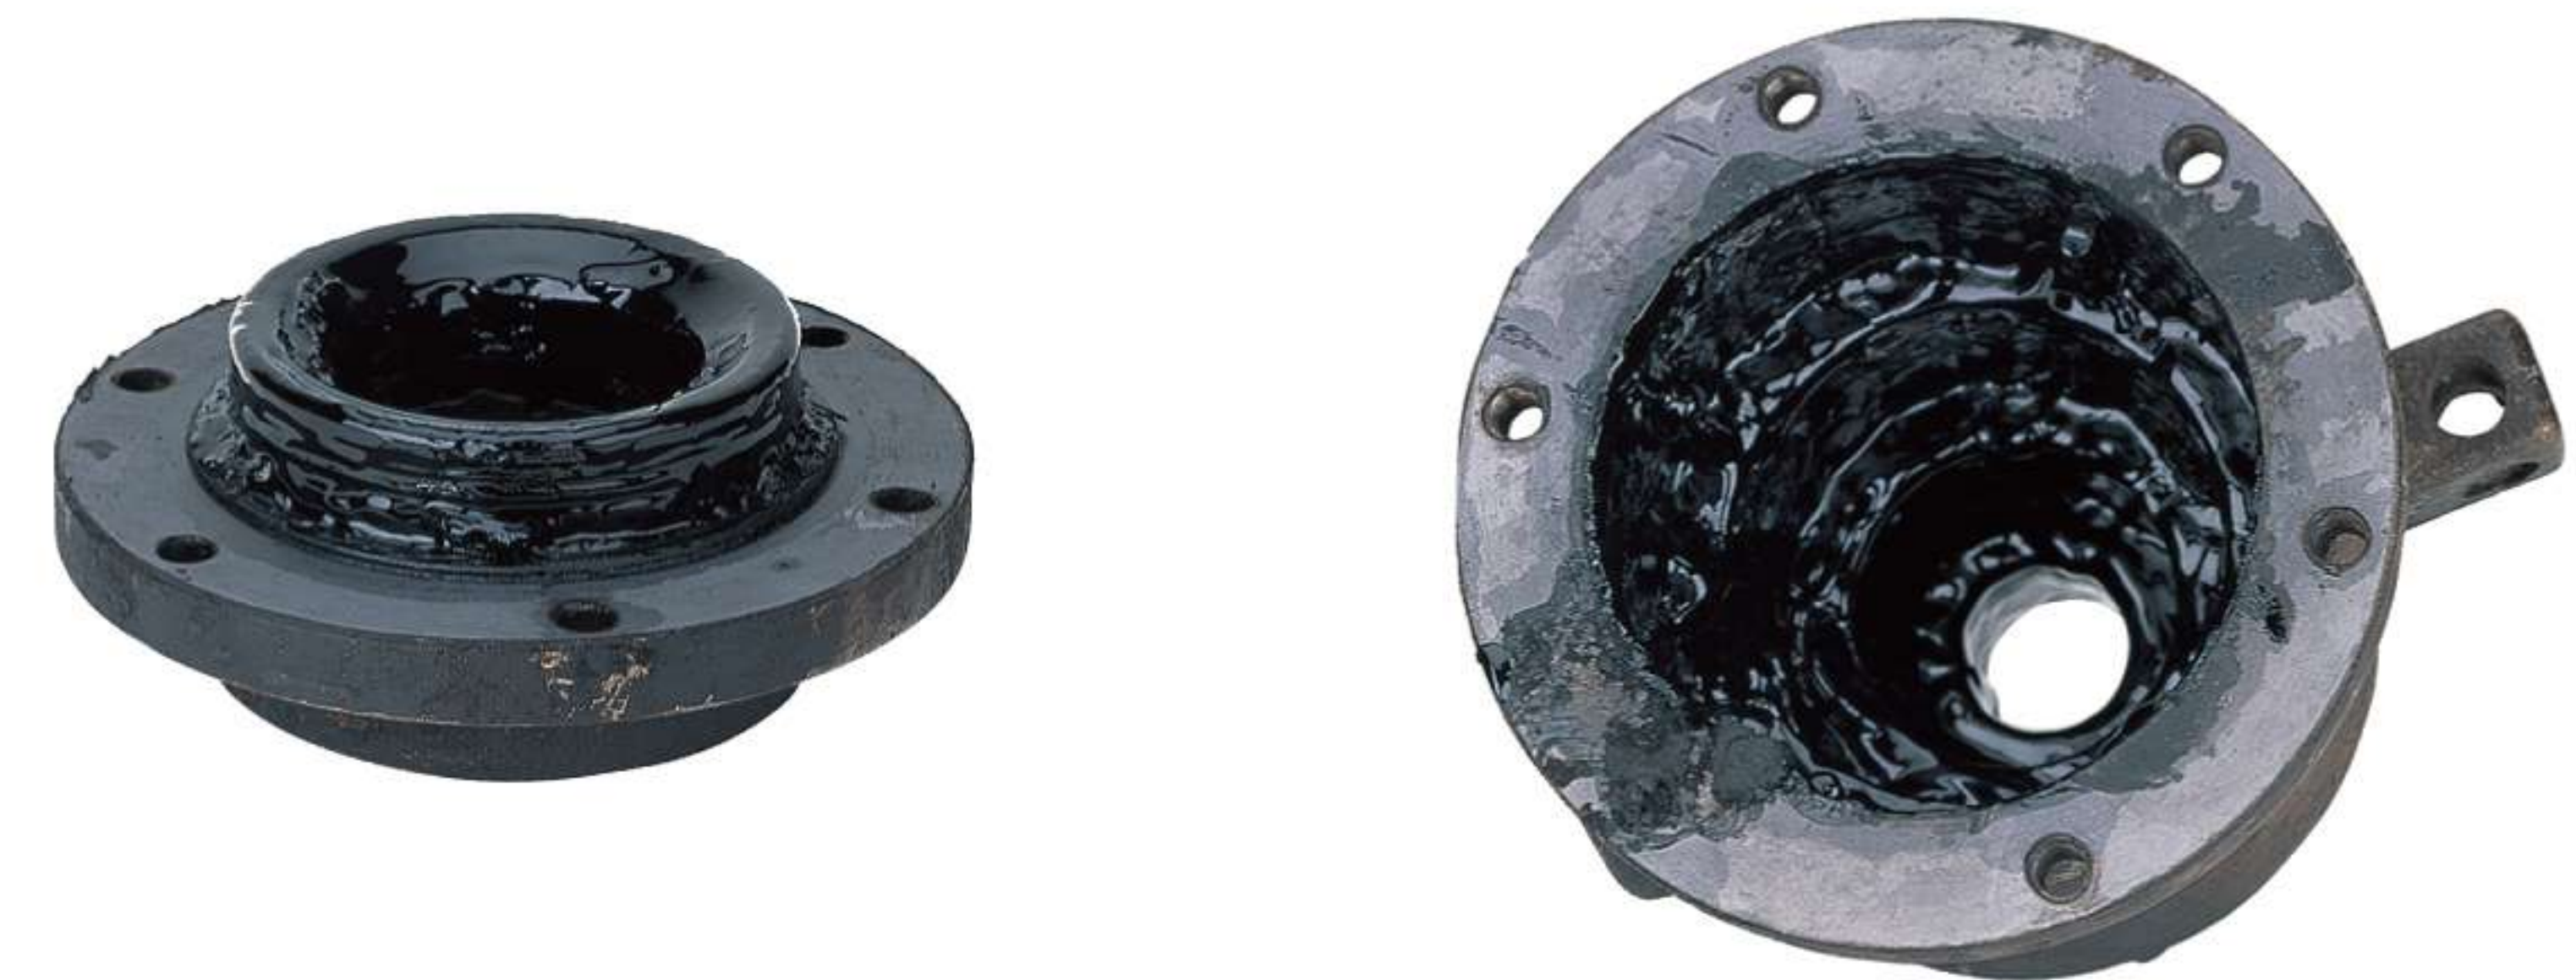
Fig.8

SERIOUS ABNORMAL WEAR

This rotary joint is used with mixing rolls. Leakage after 3 months of normal use was because there were many impurities and the quality of the oil was bad.
