There are many reasons for rotary joint leakage. This chapter only deals with leakage caused by uncleaned internal fluids. In this case, the rotary joint can be inspected and the cause determined by examining the seal rings.

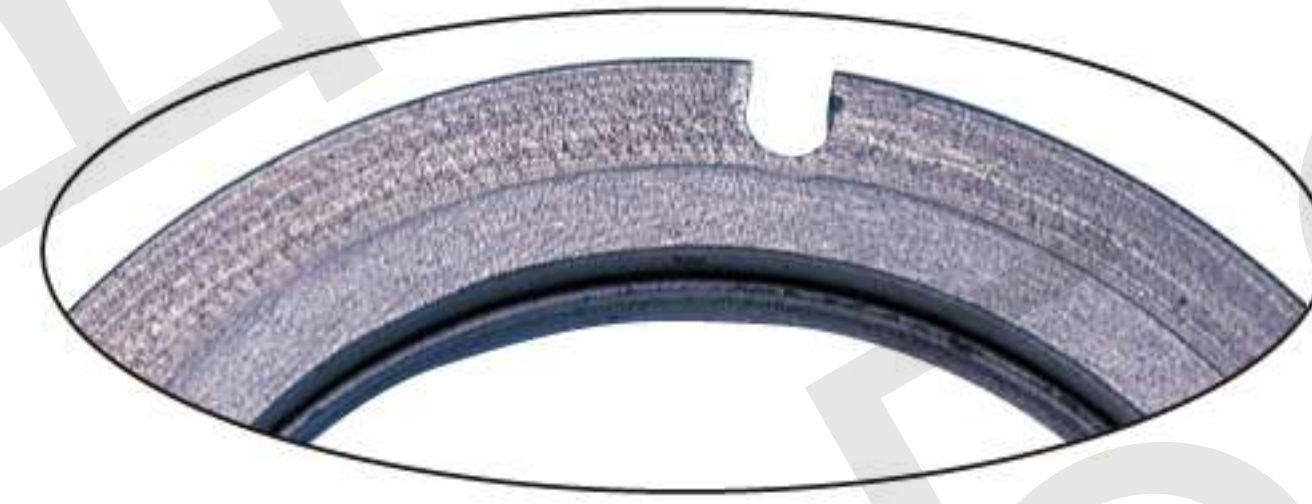
If there are no impurities in the seal face, it will be smooth and bright. Any leakage would therefore most likely not have been caused by unclean fluids.

If impurities get in the seal face, they will cause it to become rough and dull. In this case, unclean fluids would be mainly responsible for any leakage.

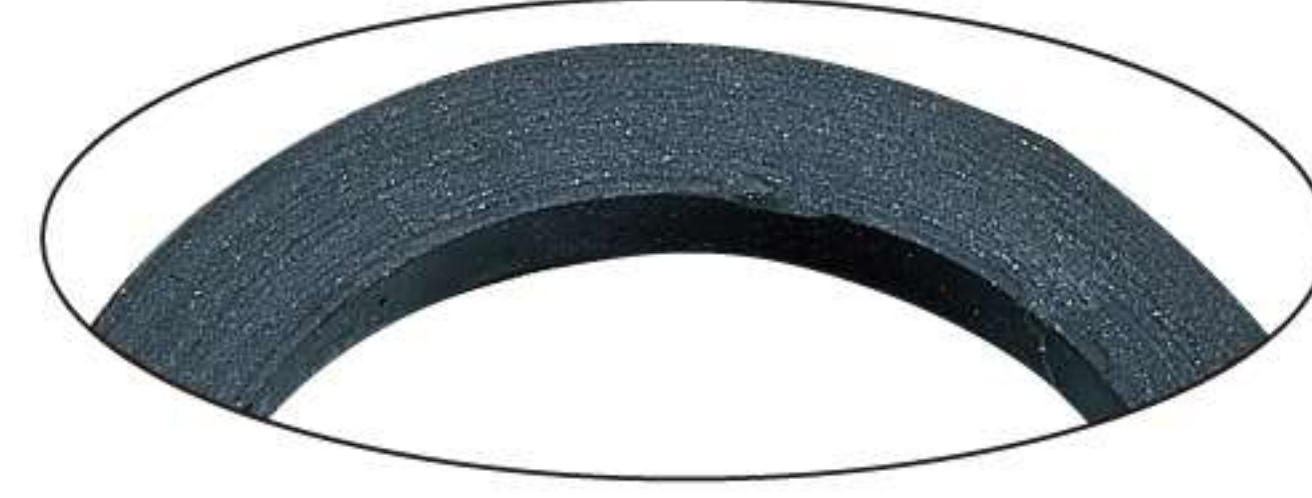
Fig.7

The severe wear shown was caused by coarse impurities. This will result in a lot of fluid being lost.

所示為很粗的不潔物造成嚴重的磨損，此狀況流體會大量洩漏。

This rotary joint is used with mixing rolls. Leakage after 3 months of normal use was because there were many impurities and the quality of the oil was bad.

此只旋轉接頭使用於軋輪機；開機時運轉正常，使用約3個月後，開始洩漏。經檢視發現內部夾雜有很多雜質，油質亦不良。
