BAD EXAMPLE OF ASSEMBLY

PIPING POINTS AND LENGTH REFERENCE

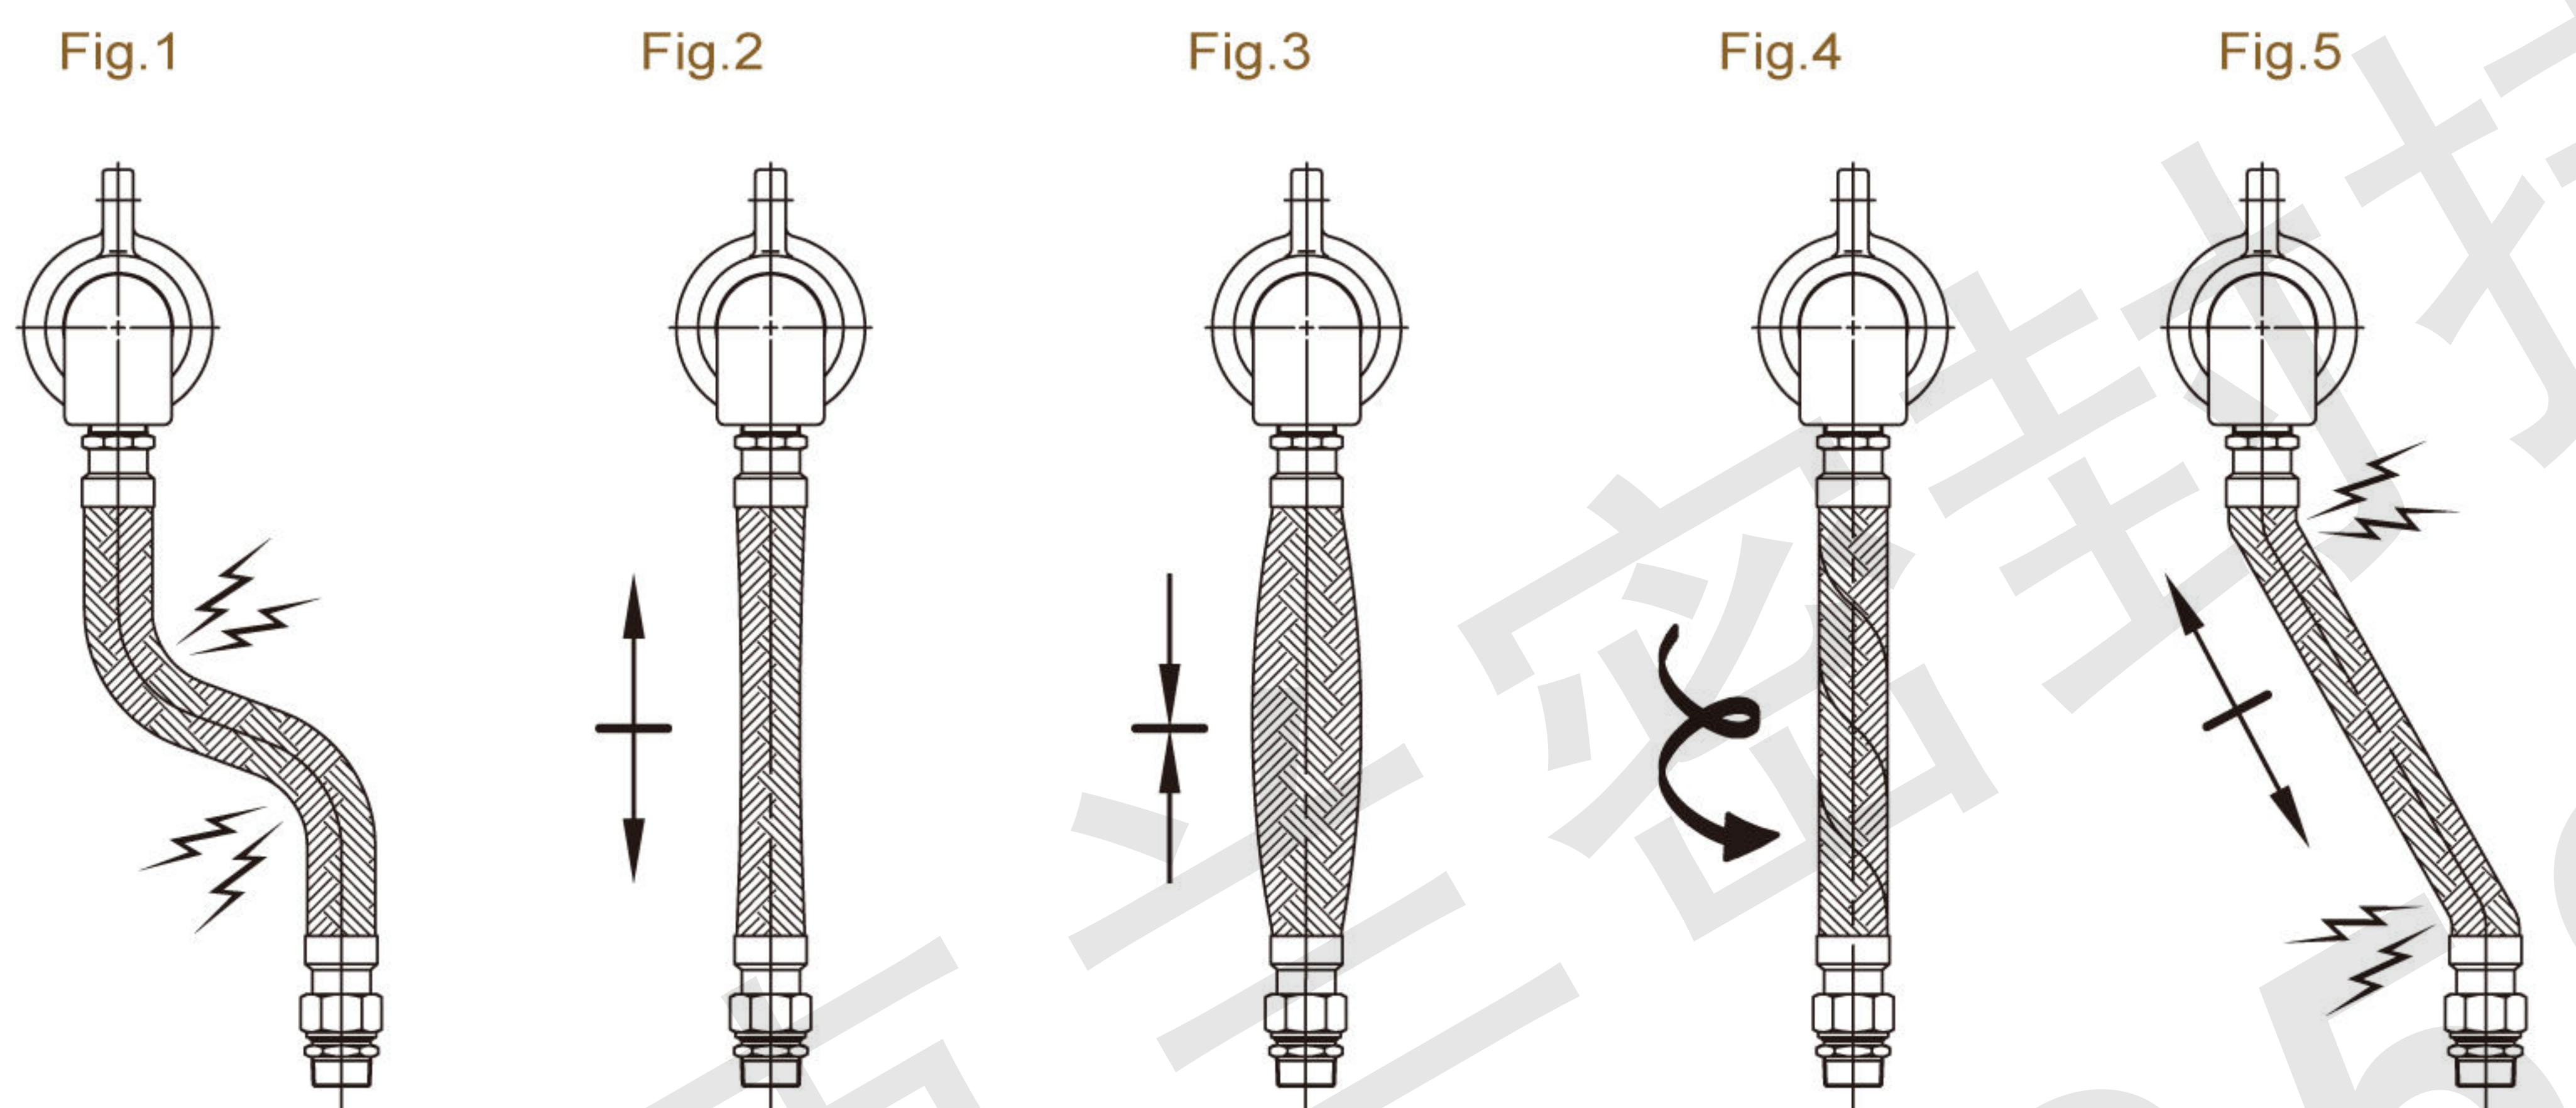
Most likely occurred negative phenomena on unplanned piping:

1. Over curved single part.
2. Over tight by too short.
3. Over squeezed by too long.
4. Already bended.
5. Over tense and tight by too short.
